MARINE INVESTIGATION REPORT
M00L0043

FALL OVERBOARD

FROM THE PASSENGER VESSEL *MISS GATINEAU*
OTTAWA RIVER
12 MAY 2000

Report Number M00L0043

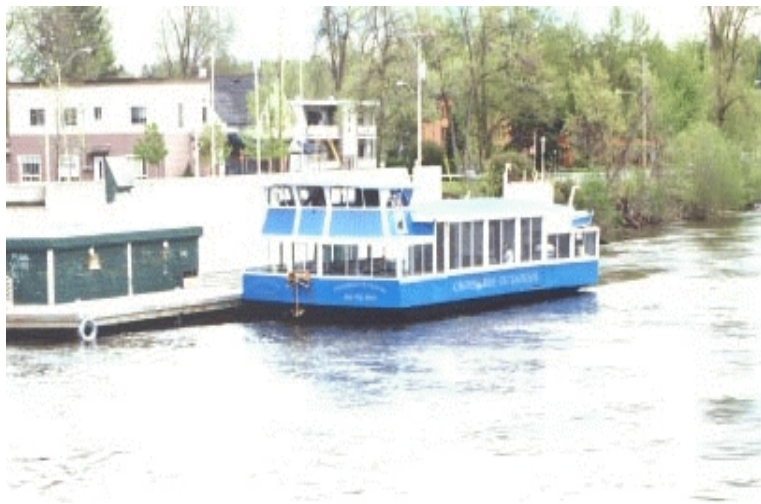
Figure 1 - *Miss Gatineau*

The *Miss Gatineau* is a converted vehicle ferry with a flat-bottom steel barge hull (see Figure 1). The navigation bridge is located at the bow above the passenger area, and the engine room is on the centre line, aft. An aluminium superstructure covers the former vehicle deck, which has been converted into a passenger area. The passenger area is arranged with a disk jockey booth aft, a bar to port, and washrooms to starboard. Forward of the disk jockey booth is an open area which was arranged as a dance floor surrounded by passenger tables. A second bar is located forward on the centre line. A square tubular handrail surrounds the passenger area to a height of 109 cm. The passenger area is surrounded by sliding glass windows, which extend from the handrail to the deckhead. The vessel is equipped with fixed quartz-halogen spotlights, which illuminate the area immediately surrounding the vessel. An unpowered, 4.5-m aluminium lifeboat is located aft on the port side of the boat deck.

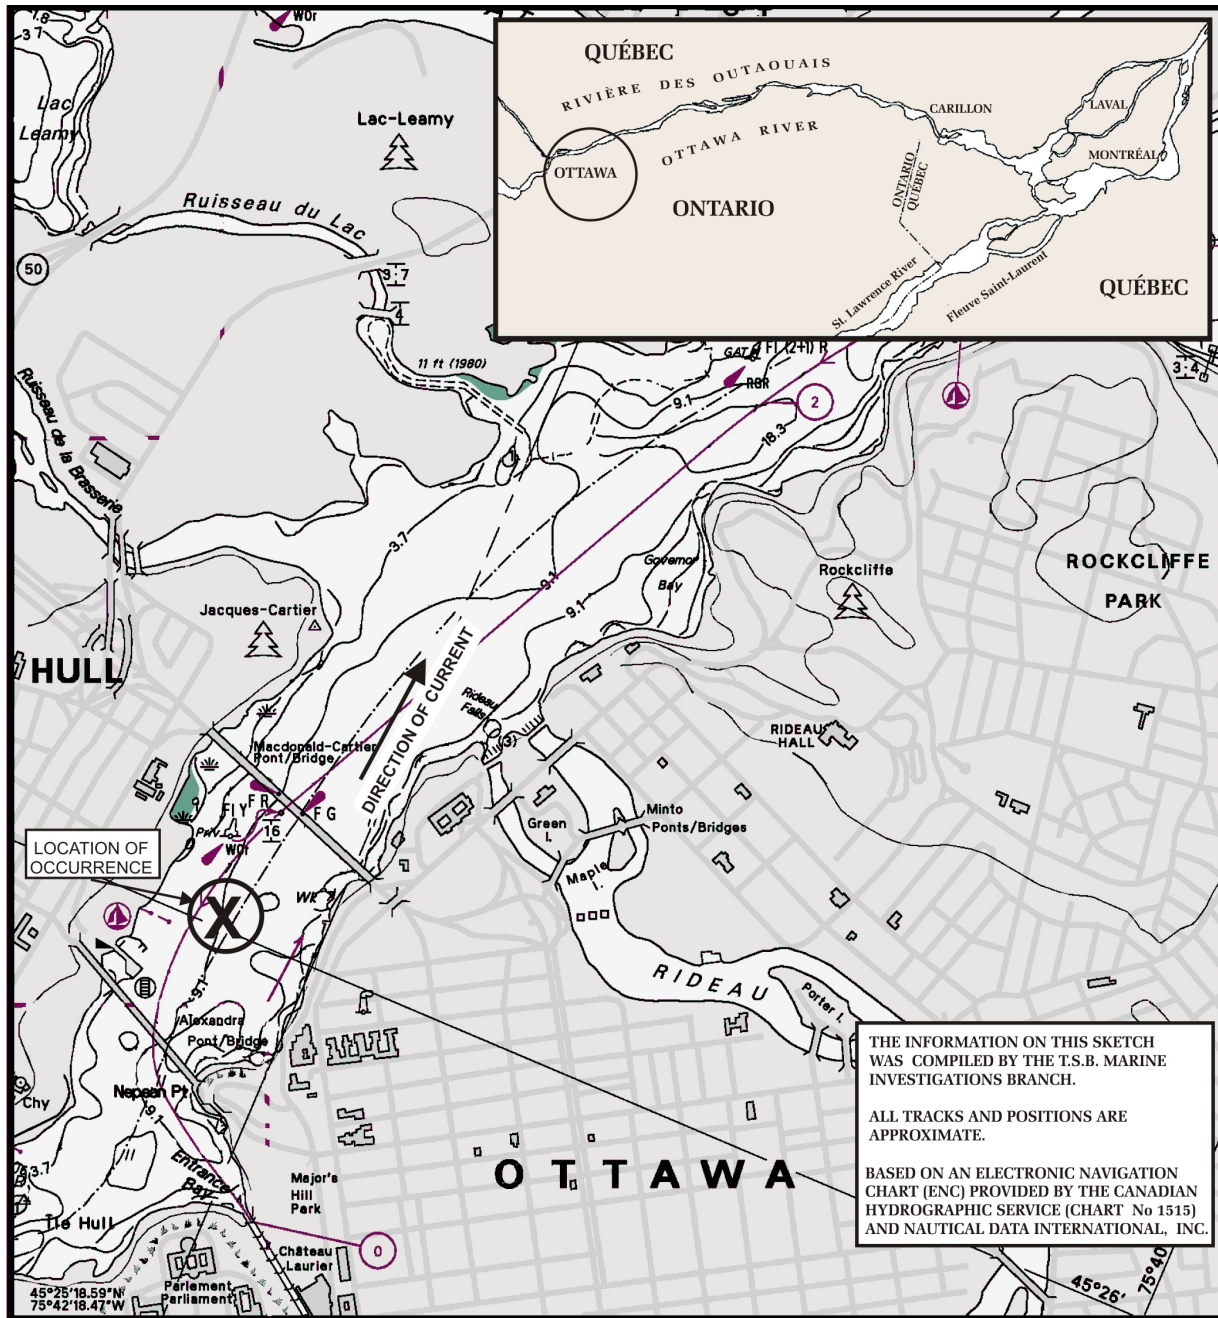
Appendix A - Sketch of the Occurrence Area

Understanding existing environmental conditions is essential in planning and executing a successful SAR operation. When the HFD and OFD water rescue units arrived on scene 15 minutes after the occurrence, they began searching the area around the piers under the Macdonald-Cartier Bridge. This was followed by a grid-pattern search down river and a search of the bays on their respective sides of the river. Being unfamiliar with the strength of the river's current, the HFD and OFD water rescue units did not appreciate or take into account the probable distance that the victim would have drifted prior to their arrival. With a minimum current of two knots, the victim would have drifted at least 925 m downstream from the location at which he fell overboard and, if still afloat, would already have been adjacent to the Rideau Falls when the HFD and OFD water rescue units arrived on scene. A more rapid deployment to a location down river, determined by analysing the probable drift in the prevailing current, might have placed the HFD and OFD water rescue units in a more effective position to locate the victim before he was overcome by hypothermia or fatigue.
